Field and laboratory investigation into scour around breakwaters

Sarah Fausset

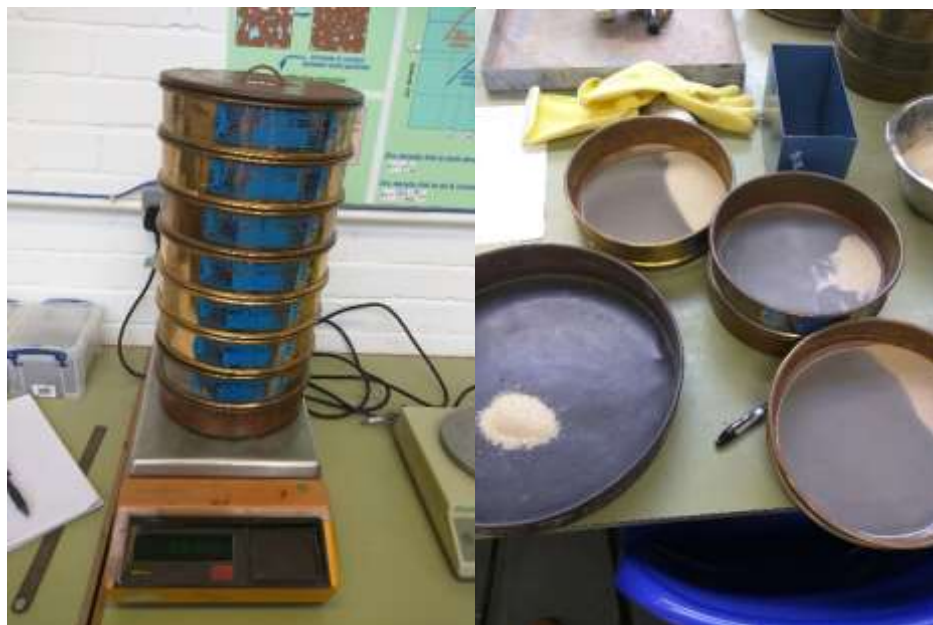
Figure 2: a) Sieve test apparatus b) Individual sieves showing collected bed material post-test.

In preparation for the preliminary experiments a sample of the sediment in the tank was taken, dried in an oven over night and sieved to examine the size of the sediment. The sediment in the tank was constant throughout the tank but the sample

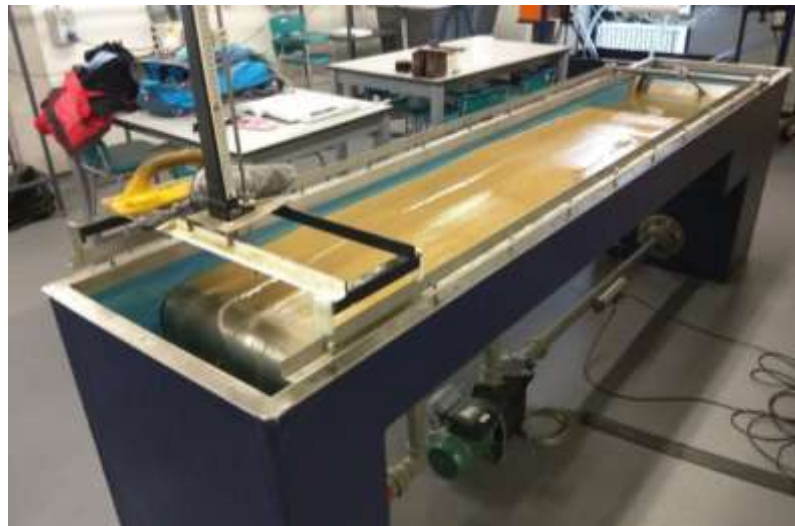
Figure 6: Alborn Rig

The Alborn rig shown in Figure 6 has a BomBa PSH Mini 80M 220-230 Volt pump that pumps fresh water through a 48.3mm diameter plastic pipe. An adjustable weir located at the downstream end of the flume acts as a sand trap as well as being used to control the water depth upstream. The level of the sand in the tank was measured using a point gauge and was levelled out to the same level for every test undertaken.

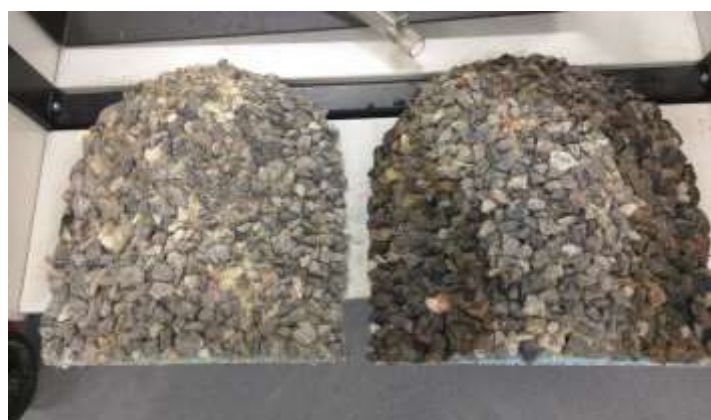
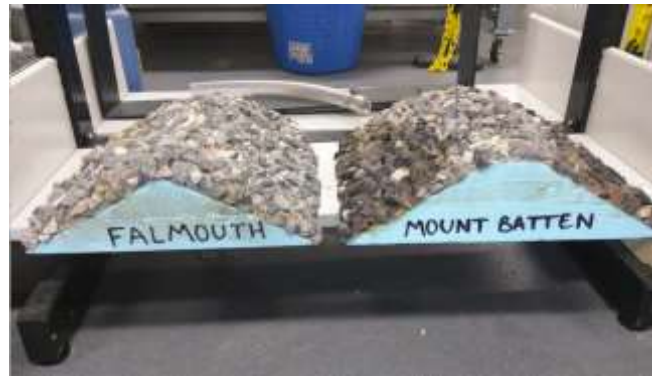
Figure 12: a) Plan view of Falmouth and Mount Batten models (L-R) b) Elevation view of Falmouth and Mount Batten models (L-R)

Froude scaling and symmetrical scaling were used to produce a model of the Mount Batten breakwater at a 1:80 scale and a model of the Falmouth breakwater at a 1:100 scale shown in Figure 12a and 12b.

Both the Falmouth and Mount Batten breakwater models made for this project were comprised of a dense foam core that geometrically represents the core layers of the breakwaters. Two layers of aggregate covered the foam core, one layer of 20mm and one layer of 10mm. The aggregate layers are attached to the foam cores using a silicone sealant which allows flow of water around the individual stones but provides a strong hold and prevents the stones being removed during testing.

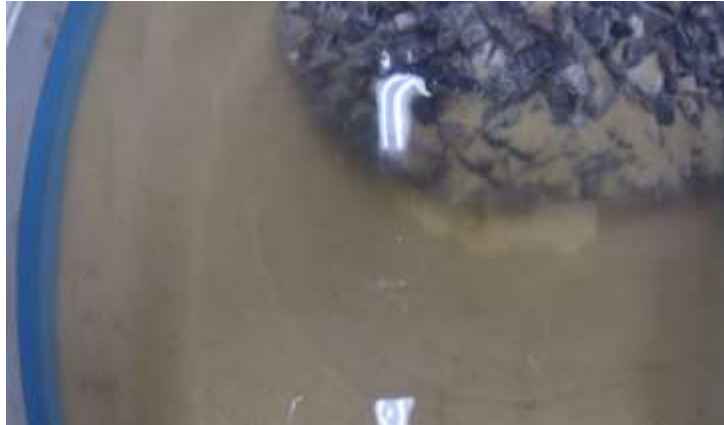
Figure 14: Falmouth model fail

Figure 14 shows the model has been lifted and exposed the wooden base underneath. The model itself weighs 6.58Kg and was subject to 40mm of water at a flow rate of 3.7l/s, the behaviour of the model was unexpected when considering the weight of the model compared to the water depth, however this problem was remedied by placing paving bricks on top of the model to weigh it down. This was an acceptable solution to the problem as in this case the point of interest is the scouring occurring around the structure and not the structure behaviour itself. The results from this particular test were omitted and the test was repeated.
